Quantitative rotorblade surface condition measurement by means of thermographic flow visualization

Dollinger, C.¹; Balaresque, N.²; Sorg, M.¹; Fischer, A.¹

¹University of Bremen, Bremen Institute for Metrology, Automation and Quality Science; ²Deutsche WindGuard Engineering GmbH

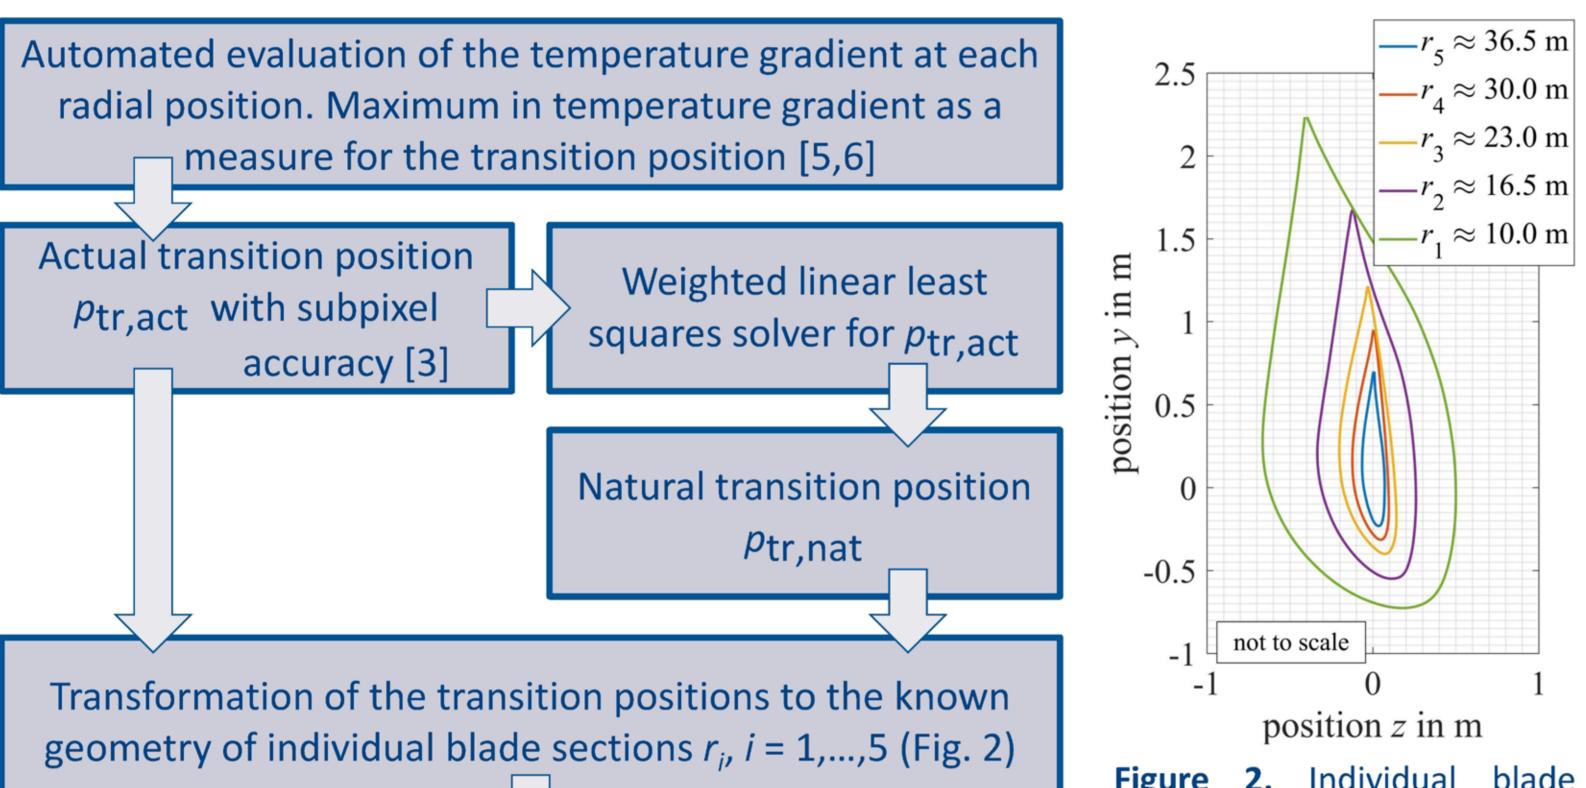
Figure 2. Individual blade sections of the rotorblade shown in figure 3 at the radial position r_i , i = 1,...,5.

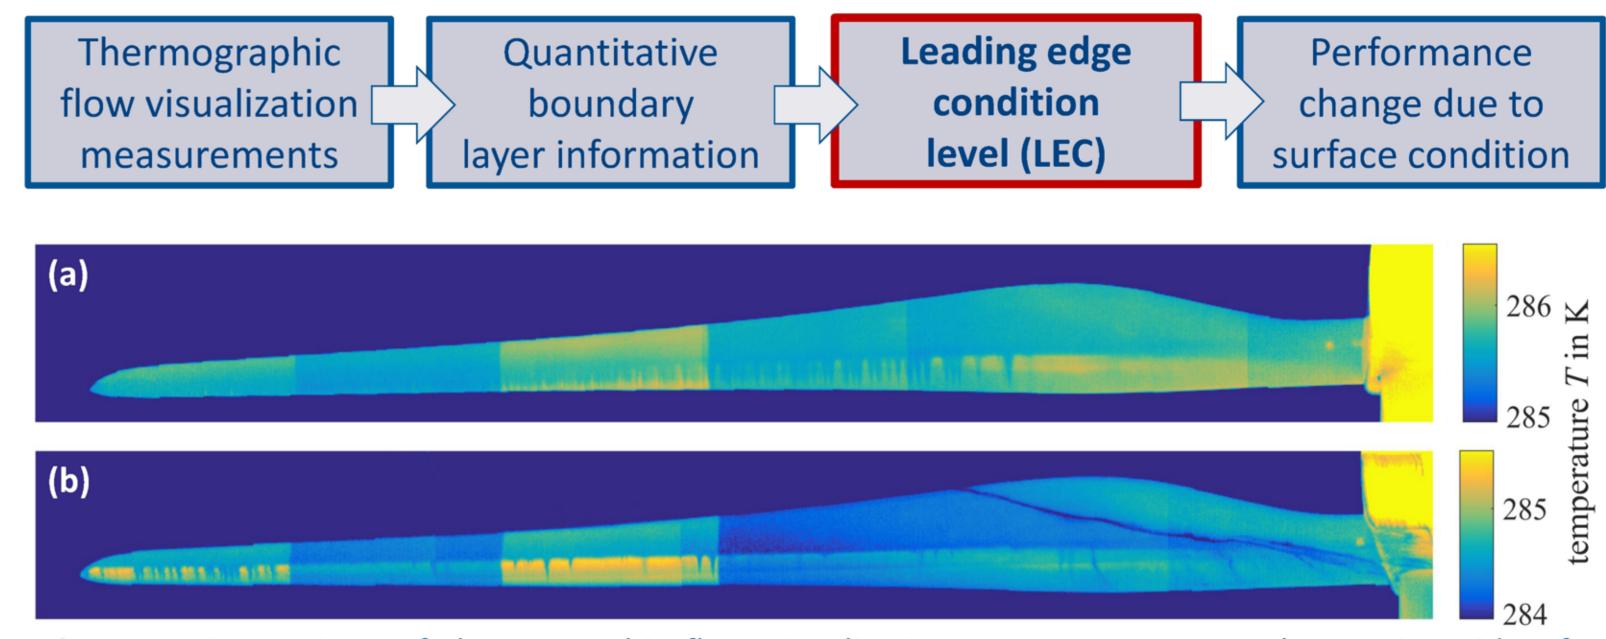
Figure 1. Comparison of thermographic flow visualization measurements on the suction side of a rotorblade on a 1.5 MW wind turbine in operation with a rotor radius of 38.5 m. Surface condition (a) before a heavy rain and (b) after the heavy rain has removed most of the contamination.

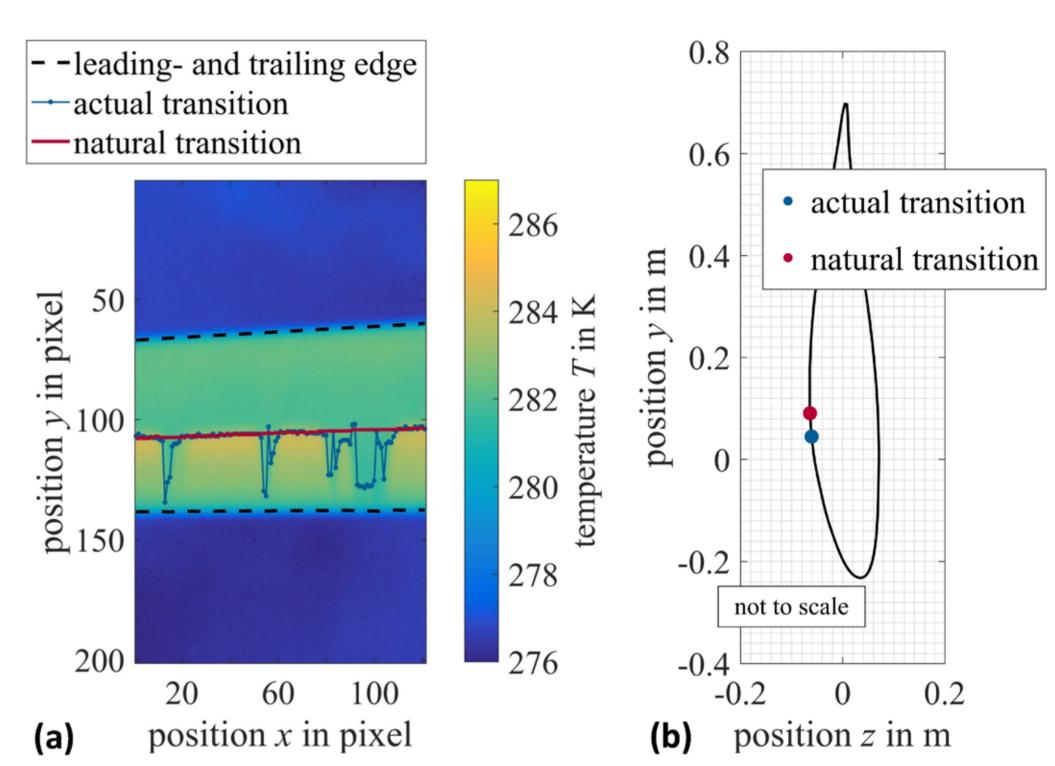
Figure 3. (a) Example for the results of the thermographic image processing for the localization of the actual and the natural transition and **(b)** the transformation of coordinates to the rotorblade geometry.

An example for the results of the image processing and the transformation to the blade geometry are shown in Fig. 3 (a) and 3 (b), respectively.

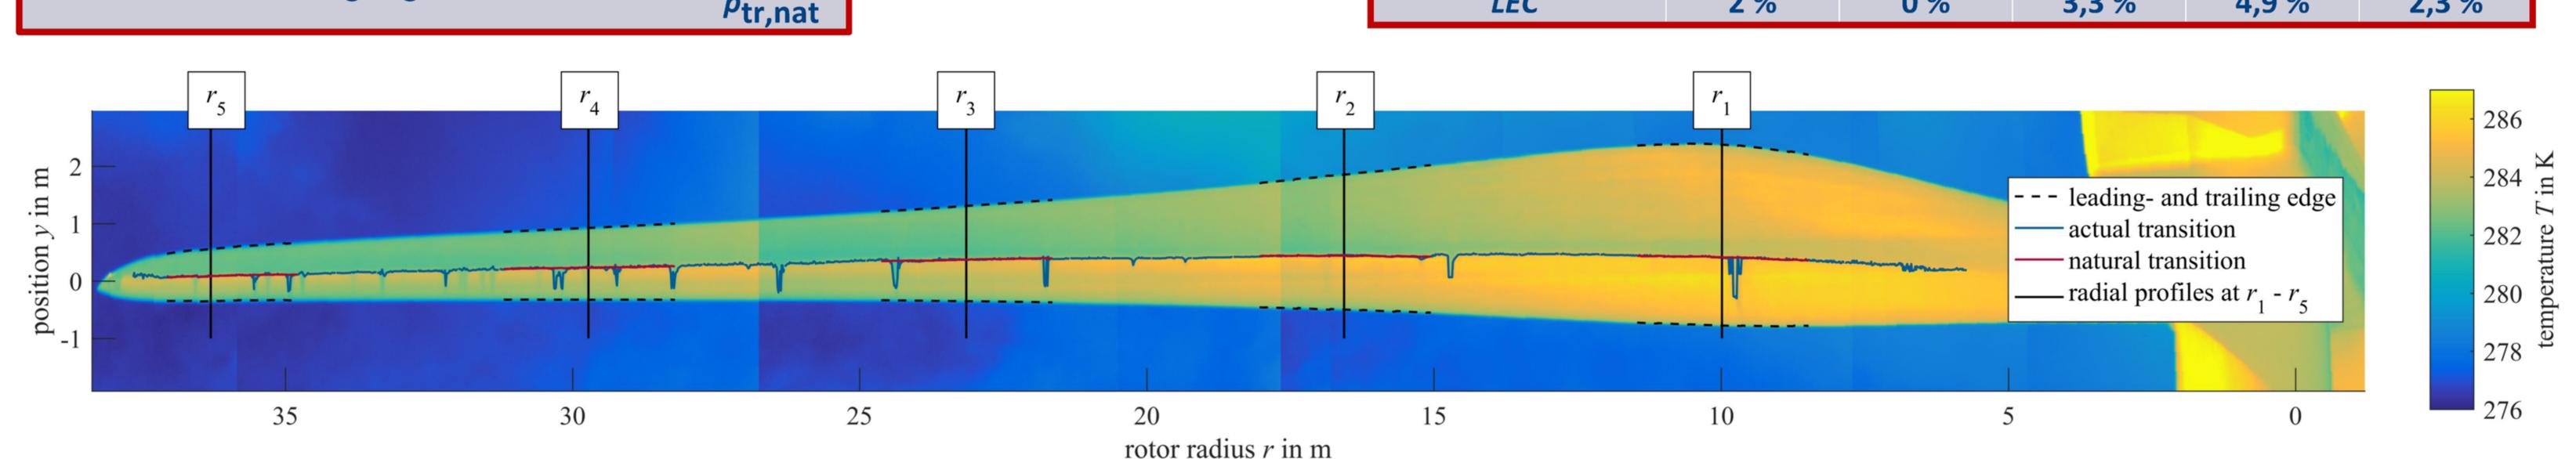
Figure 4. Surface condition measurements on the suction side of the rotorblade with a rotor radius of 38.5 m. The results at the five radial positions r_i , i = 1,...,5, are summarized in Tab.1.

A comparison of the actual and the natural transition location for all of the 5 known radial sections (±1.5 m) is shown in the thermographic measurement in Fig. 4 and the results are summarized in Tab. 1.

Radial Position r	$r_1 \approx 10,0 \text{ m}$	$r_2 \approx 16.5 \text{ m}$	$r_3 \approx 23,0 \text{ m}$	$r_4 \approx 30,0 \text{ m}$	r_5 ≈ 36.5 m
<i>p</i> tr,act	0.338	0.356	0.378	0.386	0.457
<i>P</i> tr,nat	0.345	0.356	0.391	0.406	0.453
LEC	2 %	0 %	3,3 %	4,9 %	2,3 %
